National Transportation Safety Board

Highway Accident Brief

Accident Number: HWY14FH013

Accident Type: Motorcoach run-off-road and overturn

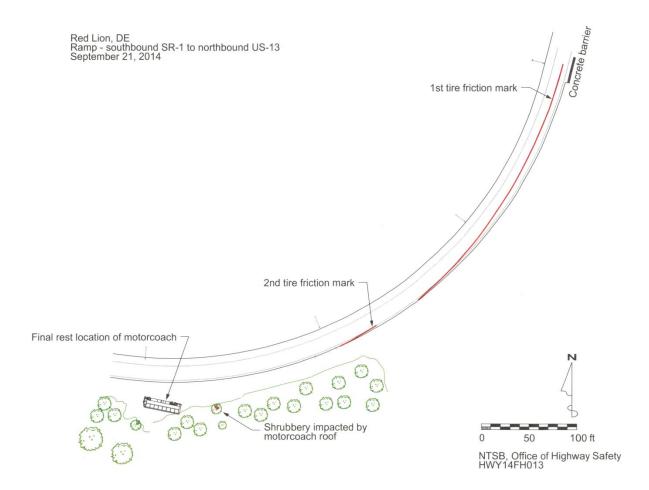
At the point where the SR-1 access ramp curves sharply to the right, the driver failed to negotiate the curve, and the motorcoach departed the left edge of the roadway. The motorcoach entered an earthen area, rotated clockwise, and overturned onto its left (driver) side and partially onto its roof, coming to rest about 25 feet off the roadway (figure 2).

Figure 2. Crash scene diagram.

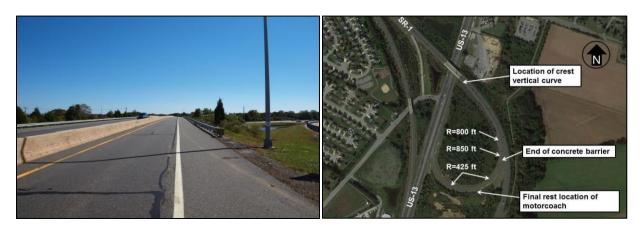
The crash occurred on the access ramp from southbound SR-1 to US-13 north near Red Lion, Delaware. The crash site is located about 7 miles southeast of Newark, Delaware. At the entrance to the access ramp, a crest vertical curve limits the visibility of the ramp ahead (figure 3, left). The 1,600-foot vertical curve provides a transition between a 2 percent upgrade slope and a 3 percent downgrade slope. Beyond this point, the ramp is a horizontal curve with varying radii as it turns to the right in the direction of travel. The radii transition from 800 to 850 feet before the end of the concrete barrier and toward the northern end of the ramp. Beyond the barrier, the ramp transitions to a 425-foot radius (figure 3, right).

Figure 3. At left, crest vertical curve at entrance to access ramp to US-13 north. At right, access ramp and relative locations of key roadway elements (adapted from figure 1).

At the time of the crash, no traffic signs were in place to warn motorists of the change in roadway curvature, or to reduce vehicle speed from 55 mph on the curved access ramp from southbound SR-1 to US-13 north.

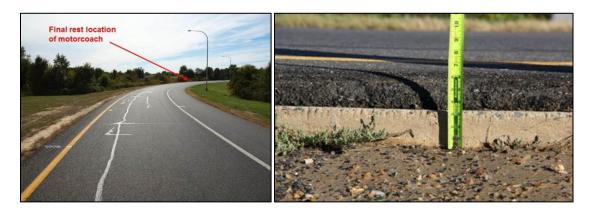
The access ramp consists of a single 14-foot-wide travel lane with a 2-foot-wide shoulder to the left and an 8-foot-wide shoulder to the right (figure 4, left). An earthen negative slope borders the left and right shoulders. Super-elevation values along the access ramp range from 4.6 to 5.5 percent.³ Values for the pavement edge drop-off along the access ramp ranged from 0.8 to 6.0 inches (figure 4, right).⁴ At the point where the motorcoach departed the roadway, the pavement edge drop-off was about 2.5 inches. This drop-off as observed along the ramp was not

a factor in the crash, but was identified as an issue to be addressed by the Delaware Department of Transportation (DelDOT) because of potential hazards to "errant vehicles." 5

Figure 4. At left, view of 425-foot-radius curve on SR-1 ramp, turning to right in direction of travel, and showing final rest location of motorcoach. At right, view of most prominent edge-of-pavement drop-off along access ramp.

With the assistance of DelDOT staff, NTSB investigators determined that the shoulder required regrading to eliminate the edge-of-pavement drop-off. In summer 2015, DelDOT regraded the shoulder to meet the elevation of the asphalt surface on the loop ramp.

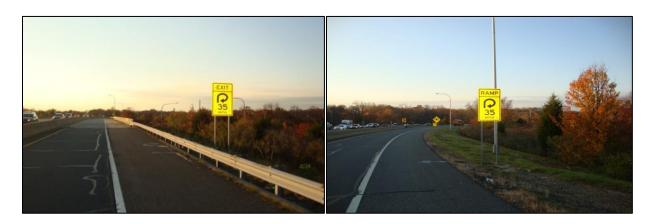
Figure 6. At left, new 35-mph combination horizontal alignment/advisory exit sign located in advance of crest vertical curve. At right, new 35-mph combination horizontal alignment/ramp speed sign located near 800-foot radius. (Source: DelDOT)

On October 9–10, 2014, DelDOT installed new traffic signs on the access ramp that meet the requirements of the 2009 MUTCD. These signs include the following:

- A 35-mph combination horizontal alignment/advisory exit sign (W13-6) located before the crest vertical curve (figure 6, left).
- A horizontal alignment sign (W1-15) with a 35-mph advisory speed plaque sign (W13-1P) located beyond the crest vertical curve.
- A 35-mph combination horizontal alignment/ramp speed sign (W13-7) located near the 800-foot radius (figure 6, right).
- A truck rollover warning sign (W1-13) with a 35-mph advisory speed plaque sign (W13-1P) located near the 850-foot radius (figure 7, left).

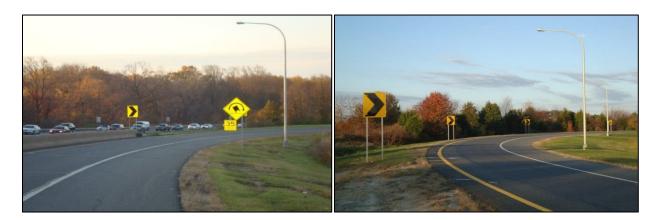
Figure 7. At left, new truck rollover warning sign with 35-mph advisory speed plaque sign located near 850-foot radius. At right, new chevron signs spaced at 120-foot intervals along loop ramp. (Source: DelDOT)

• Thirteen high post-mounted chevron signs (W1-8) spaced at 120-foot intervals along the loop ramp (figure 7, right).²³
